# NATIONAL MARITIME MUSEUM S A N F R A N C I S C O

CONDITIONS INVESTIGATIONS  
AND  
WATERPROOFING ASSESSMENT

SAN FRANCISCO MARITIME NATIONAL HISTORIC PARK  
NATIONAL PARK SERVICE

ARCHITECTURAL RESOURCES GROUP  
PIER 9, THE EMBARCADERO  
SAN FRANCISCO, CA 94111

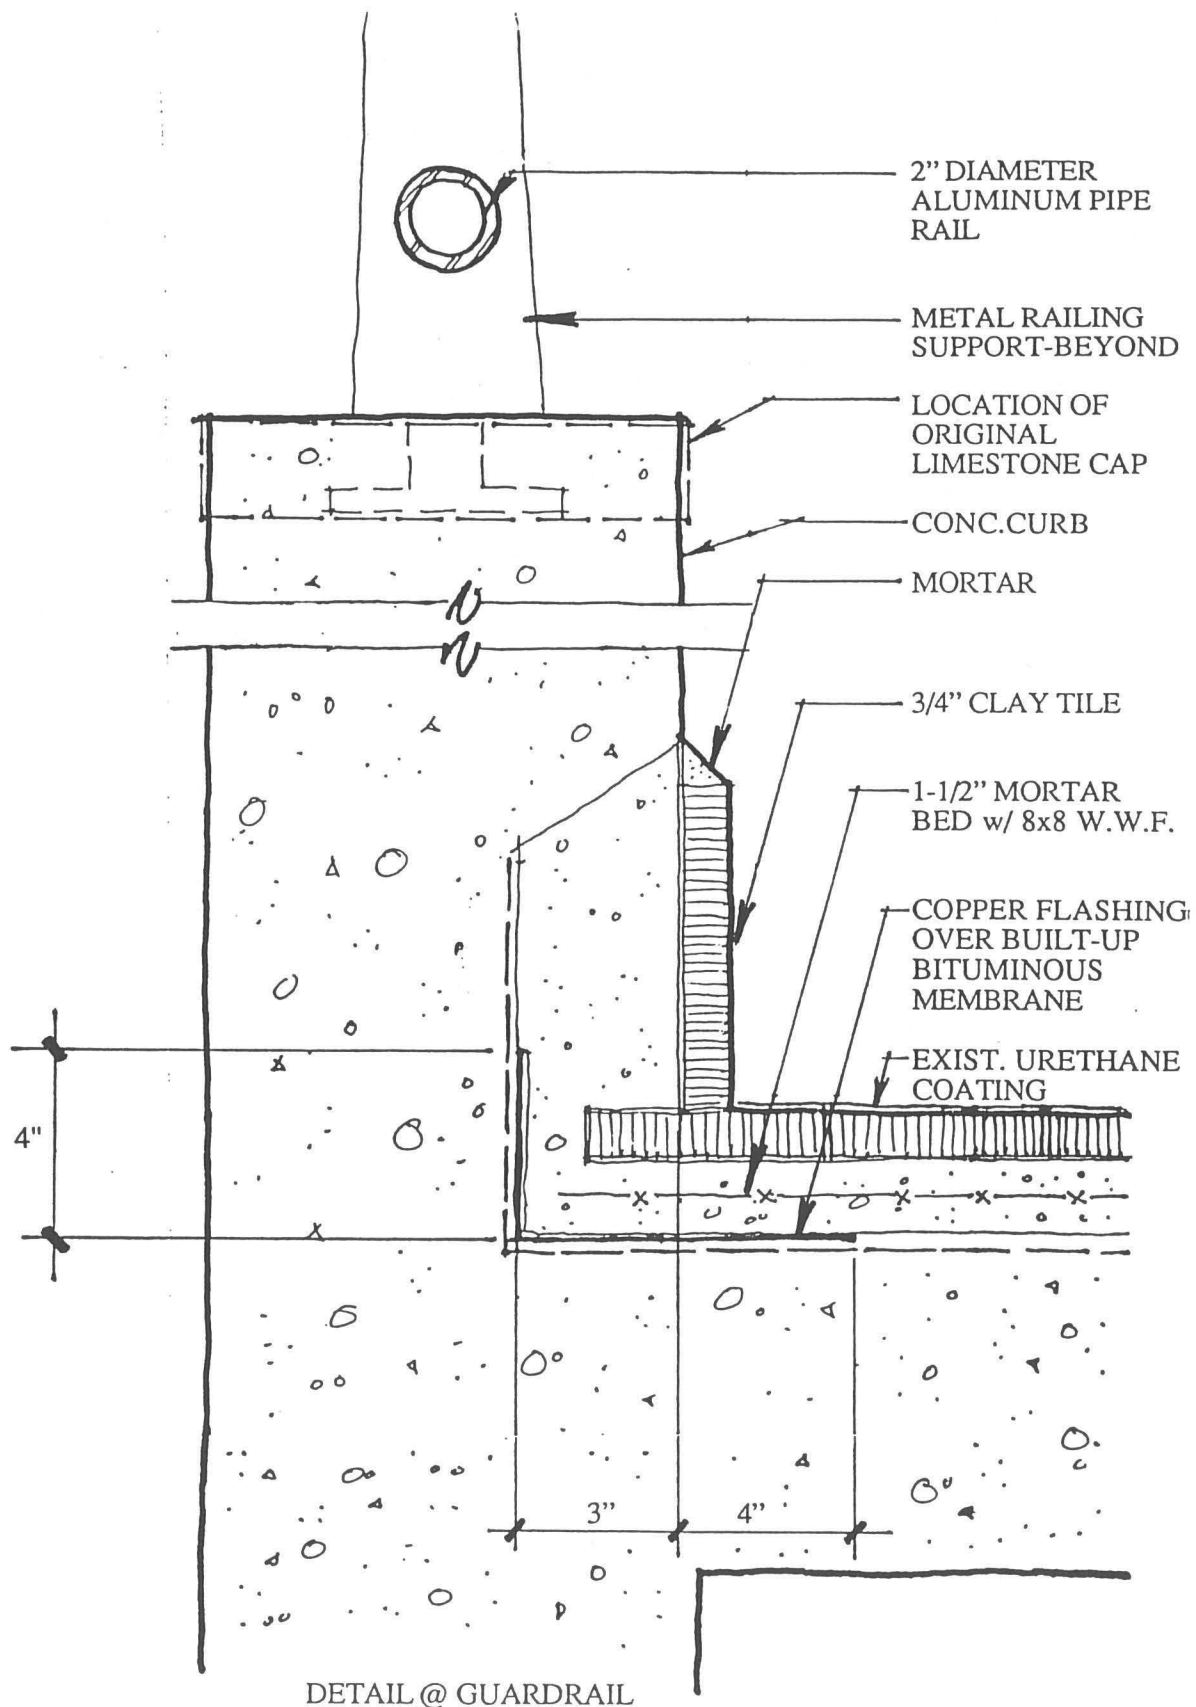
Water infiltration through these decks into the building has been a problem for many years as noted previously under MAINTENANCE HISTORY. There are several areas in the second and third floor interiors of water damaged plaster.

A general survey of the decks was made in order to identify areas where water was likely to penetrate. Damaged or cracked tiles and curbs were difficult to identify as conditions were hidden by the urethane coating. There were several areas where curb damage was obvious, due primarily to expansion of corroding steel imbedded in the concrete. Locations where loose urethane coating was removed during the repair work were examined in order to determine the condition of the pavers. Cracks were noted through tiles and in mortar joints. It was not possible to definitely correlate damaged areas of the roof with areas of water leaks within the building. This suggests that water may be traveling some distance within the building assembly before it appears on interior walls and ceilings.

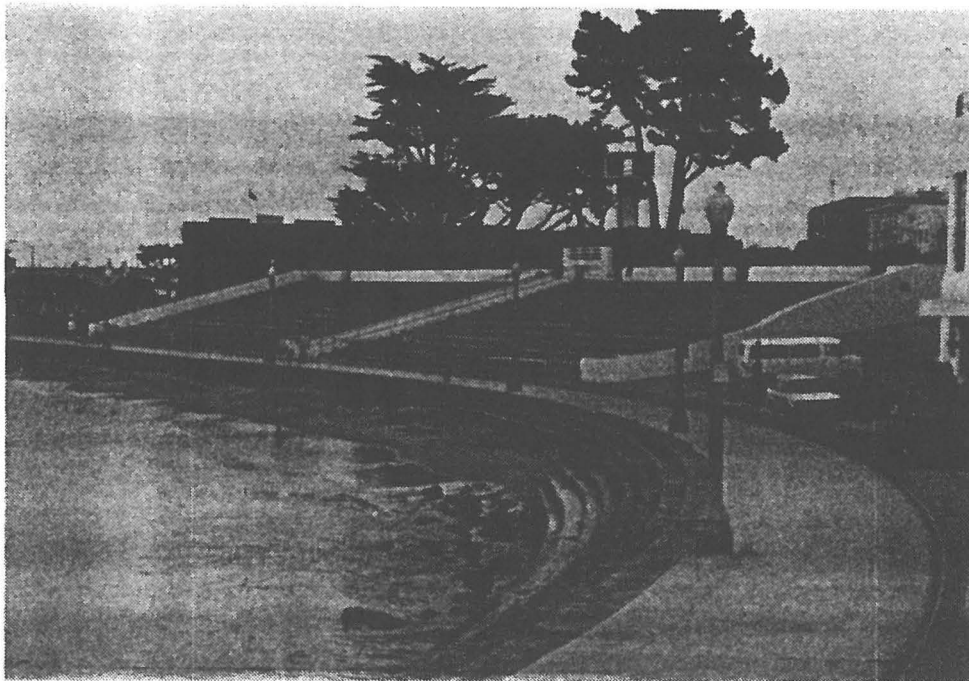
*Bleachers east of the museum building. Photo by ARG.*

some damage. There was no significant difference between exposed surfaces of the three bleachers; cracks and spalls were noted on each. This suggests that moisture is penetrating all of the bleachers to some degree, and that deterioration will continue.

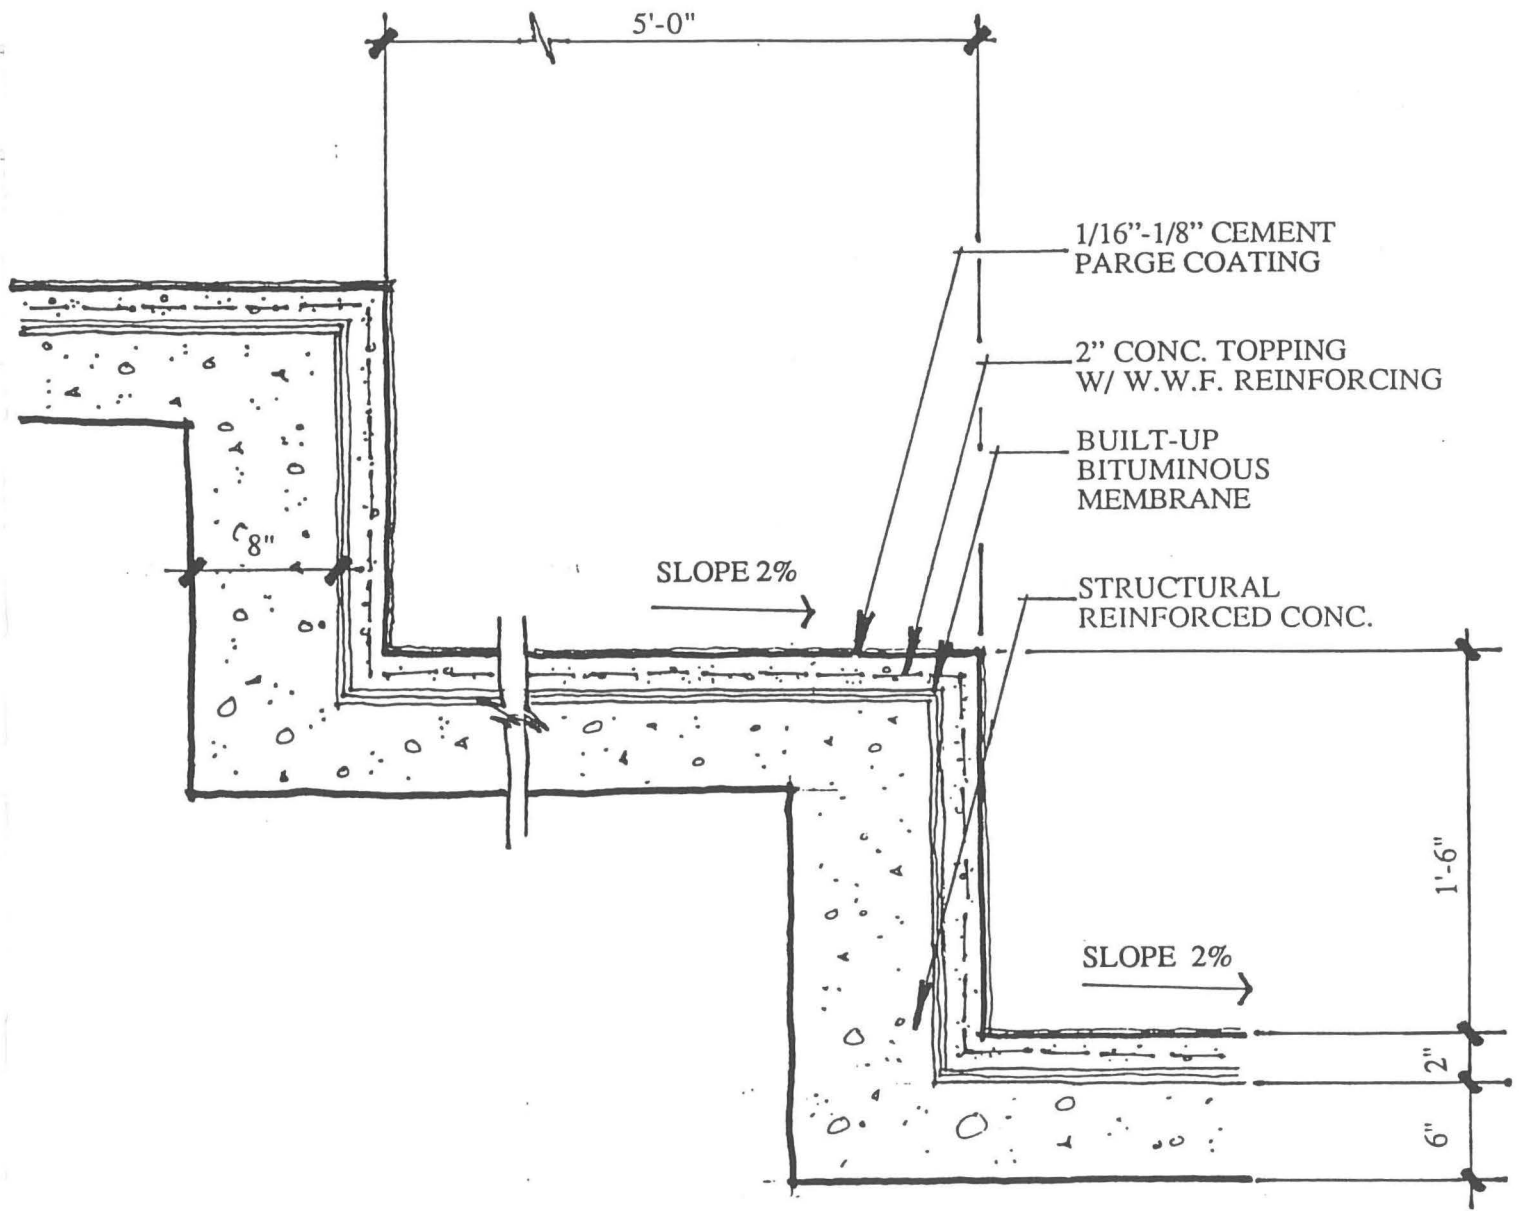
EXISTING BLEACHER DETAIL

The construction of the bleacher is similar to that of a stairway with reinforced concrete treads and risers. Over the concrete treads and risers is a 4-ply bituminous membrane, followed by a 1-1/2 to 2 -inch thick concrete topping which is also reinforced. The topping is coated with cement plaster parging (the drawing on the following page indicates the existing conditions of the bleachers).

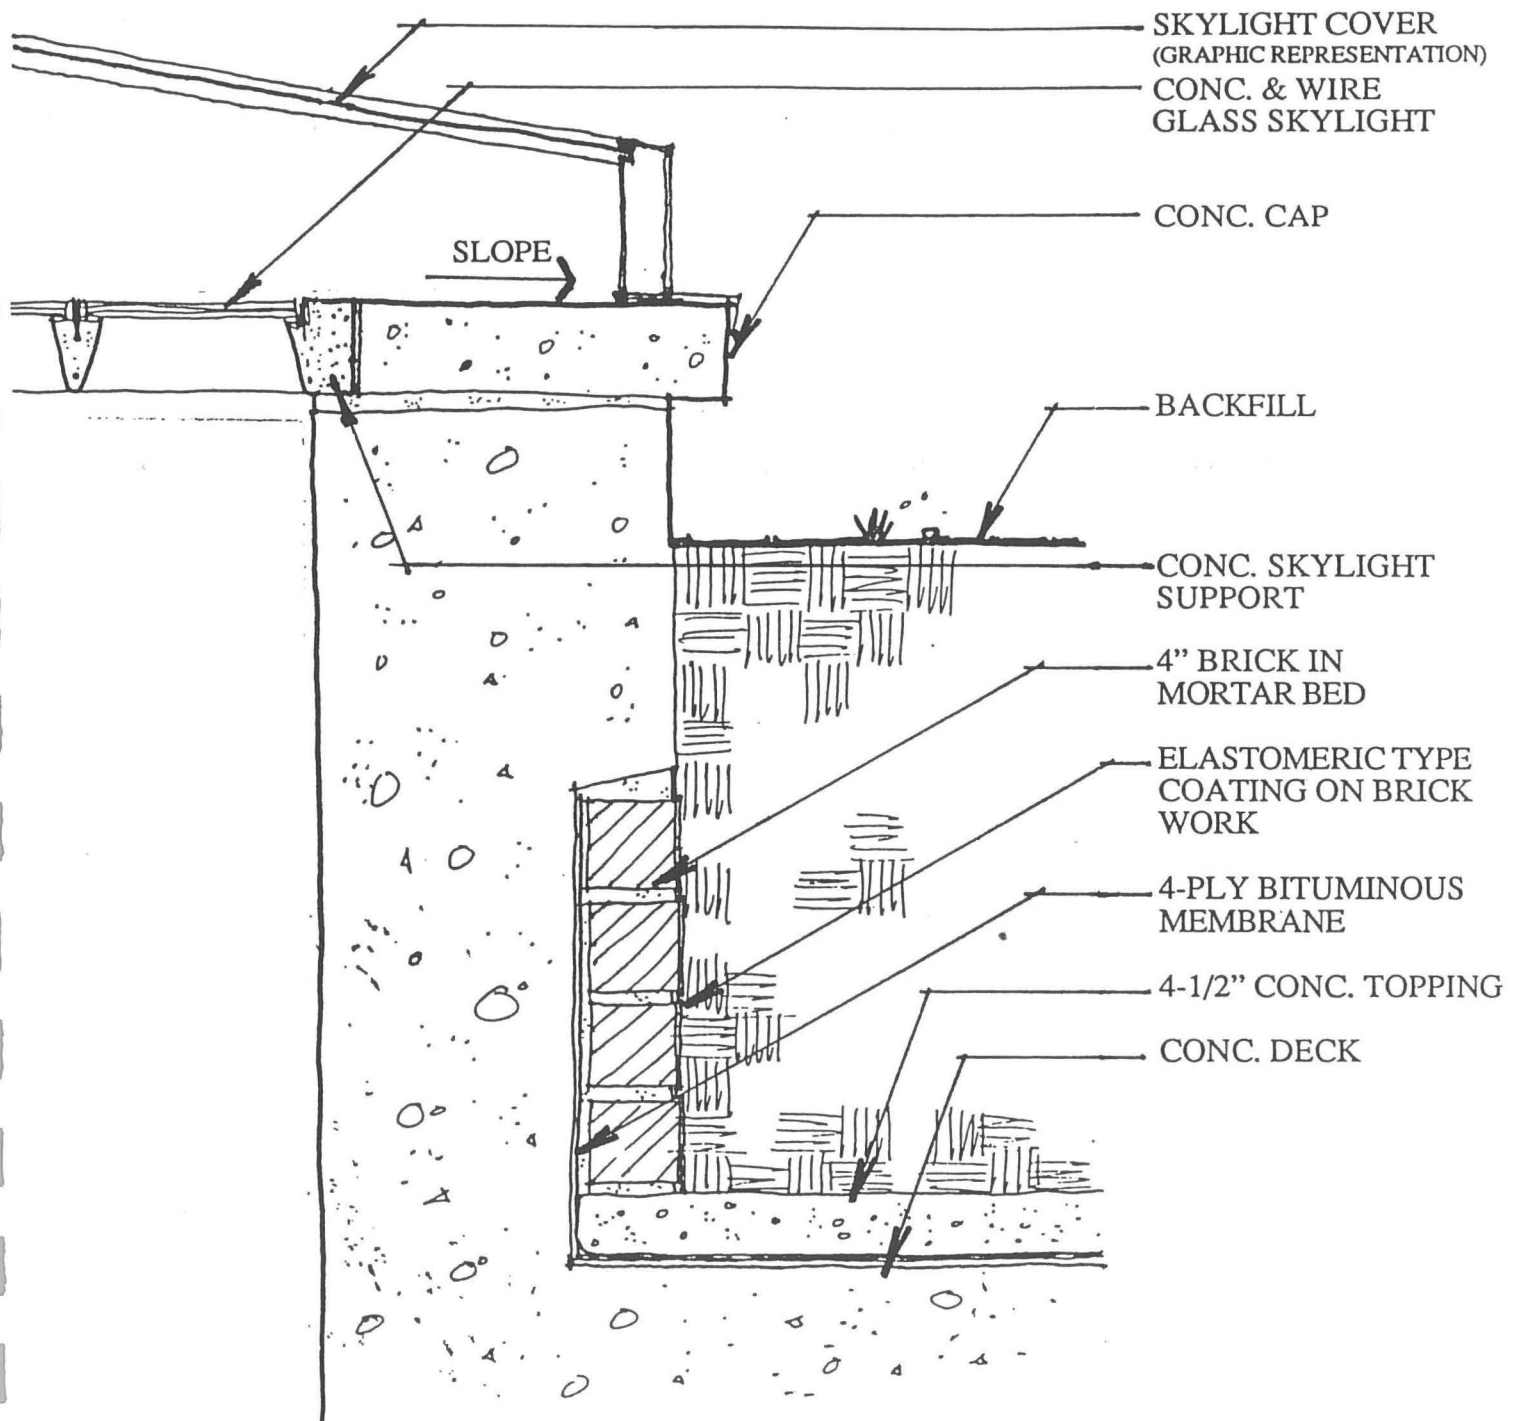
EXISTING DETAIL AT SKYLIGHT

One excavation was made adjacent to a skylight curb at the north end of the building. The depth of soil was approximately 2-feet. Beneath the soil was a 4-1/2" thick layer of concrete laid over a built-up bituminous membrane which in turn was placed over the structural slab. The base of the skylight curb was brick with an elastomeric coating suggesting that an attempt was made to waterproof the curbs somewhat recently (see detail on page 24).

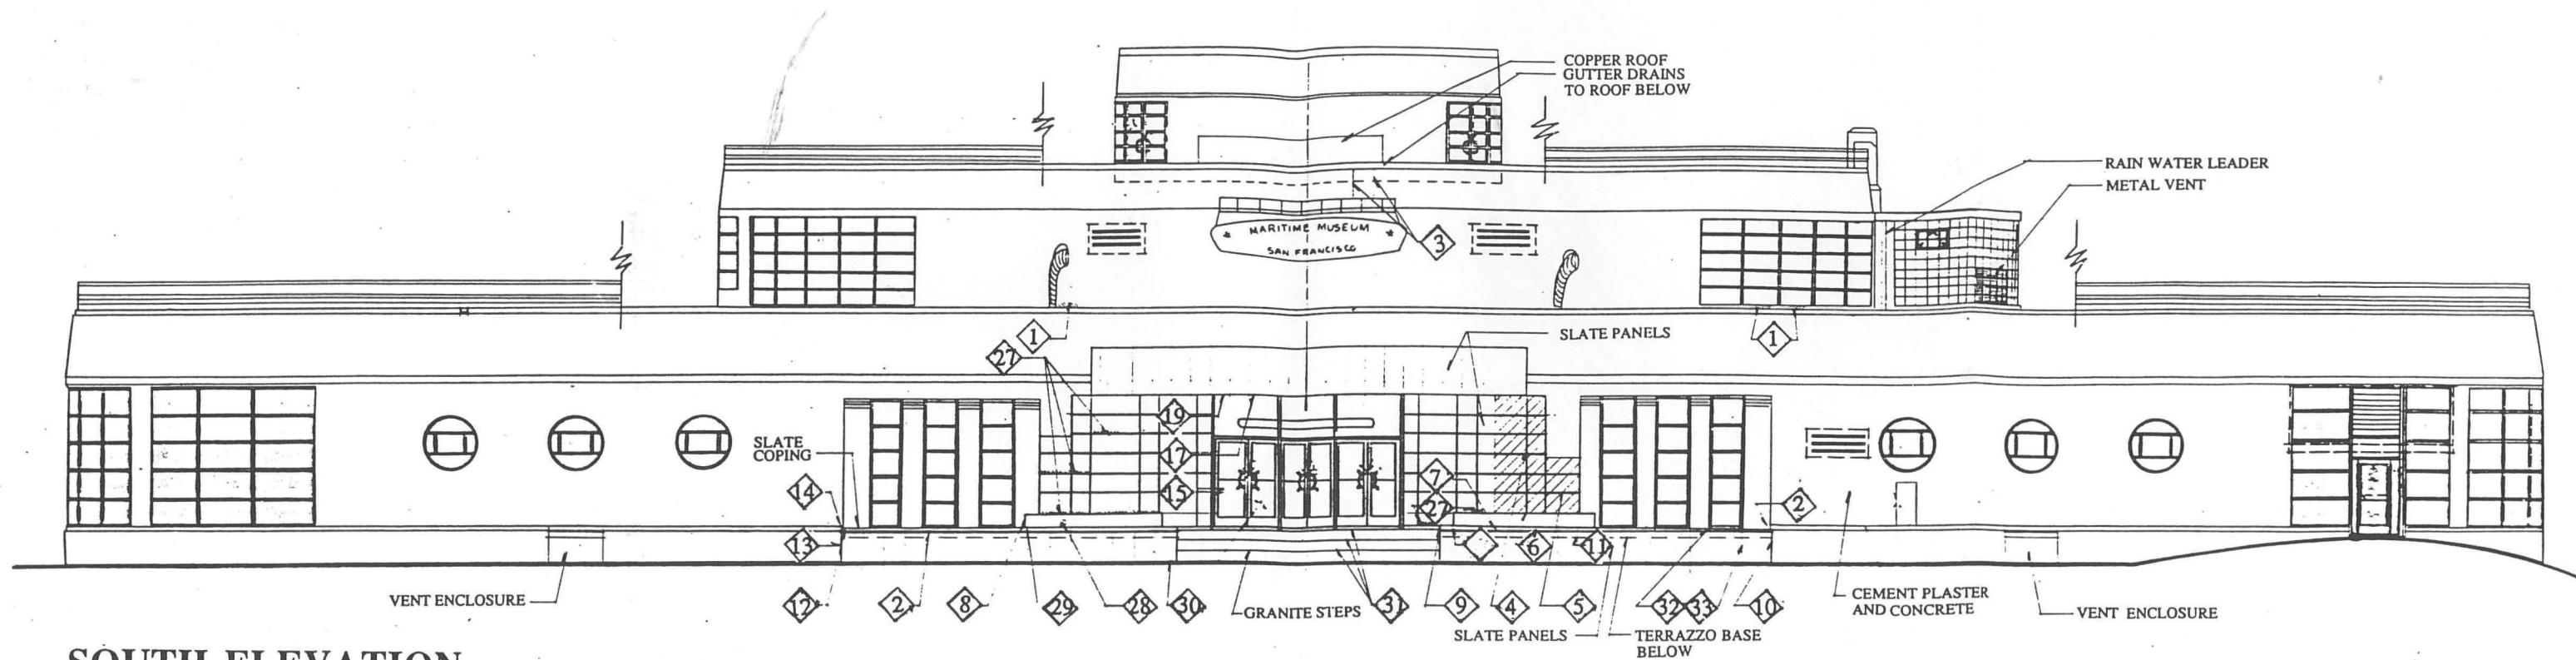
## SOUTH ELEVATION

Heavy build up of coatings causing general horizontal striations.

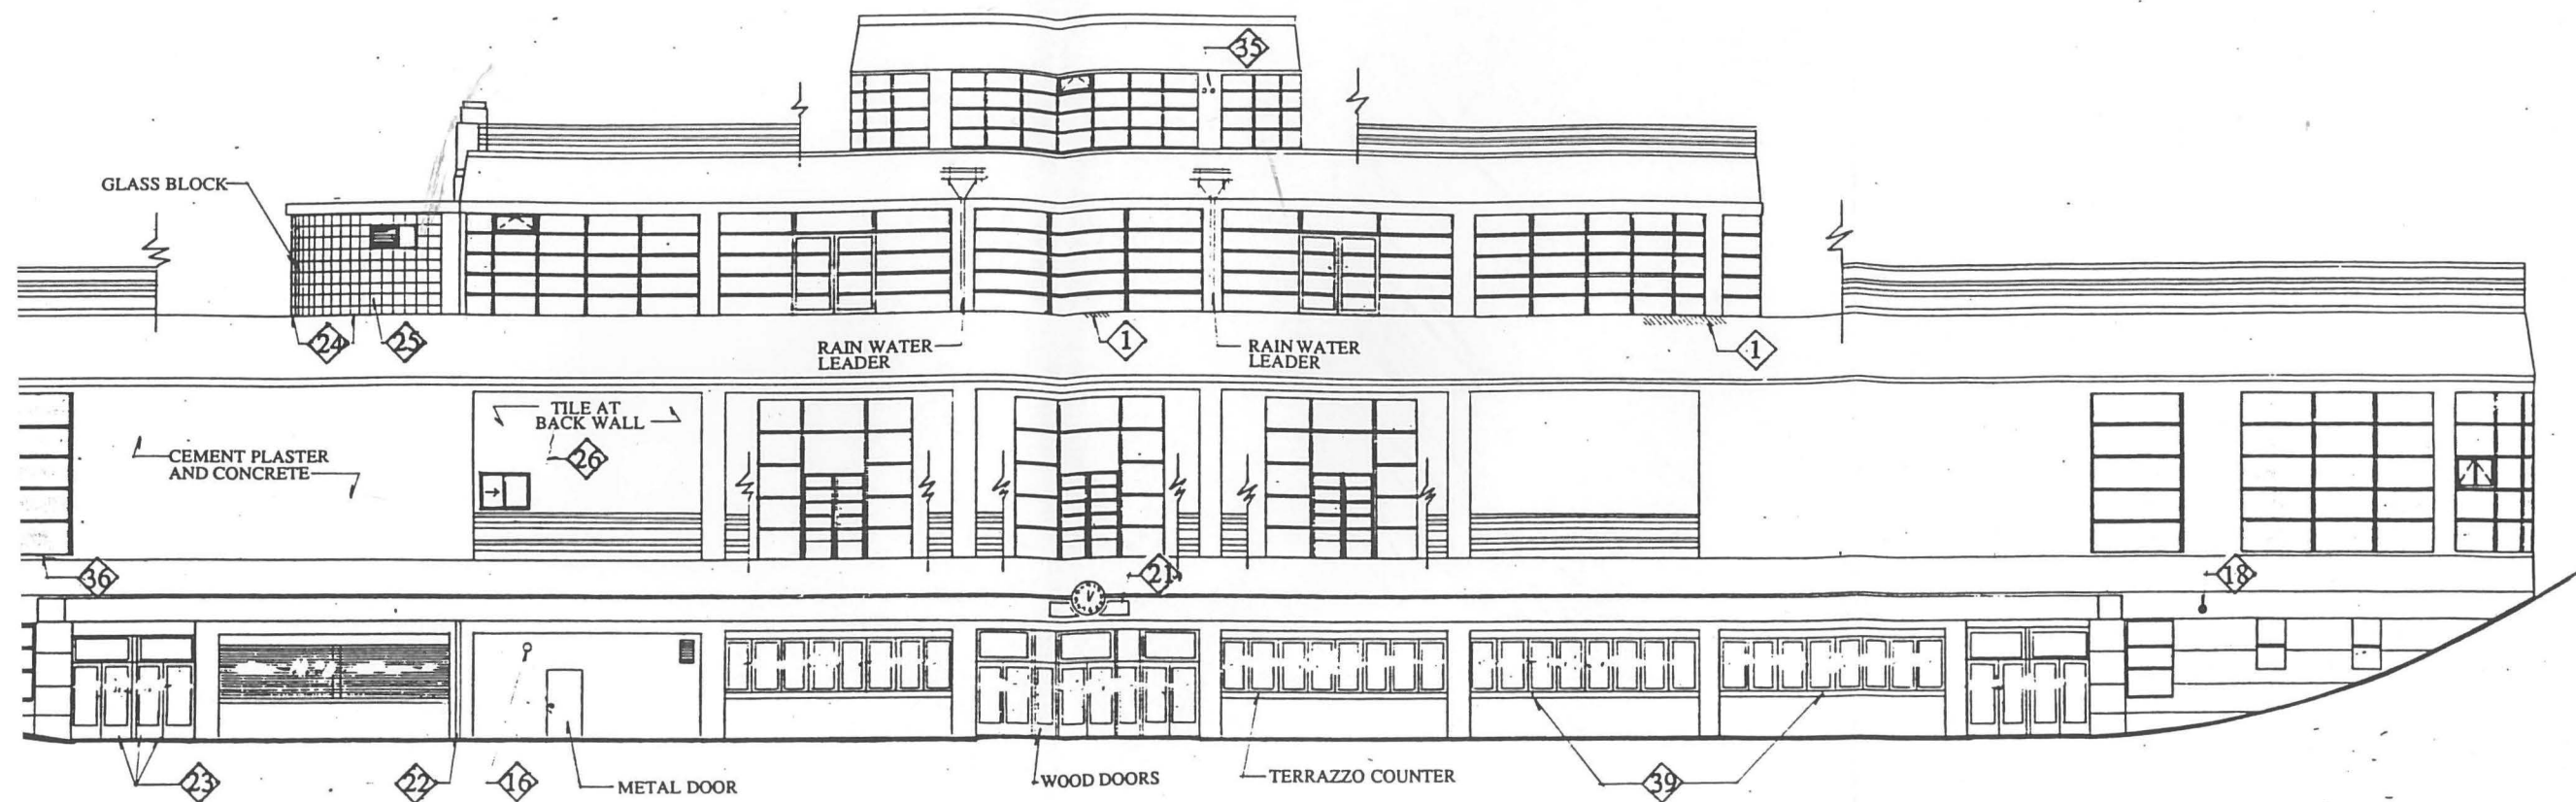
General discoloration and delamination of slate at unit
